Lessons learned during revamp of 34 year-old reformer

Retrofit of heater required unique engineering, design and construction methods

K. EDMUNDS, North Atlantic Refining Ltd., Come by Chance, Newfoundland, Canada, **S. UZELAC** and **R. NEWNHAM**, Born Heaters Canada ULC, Calgary, Alberta, Canada

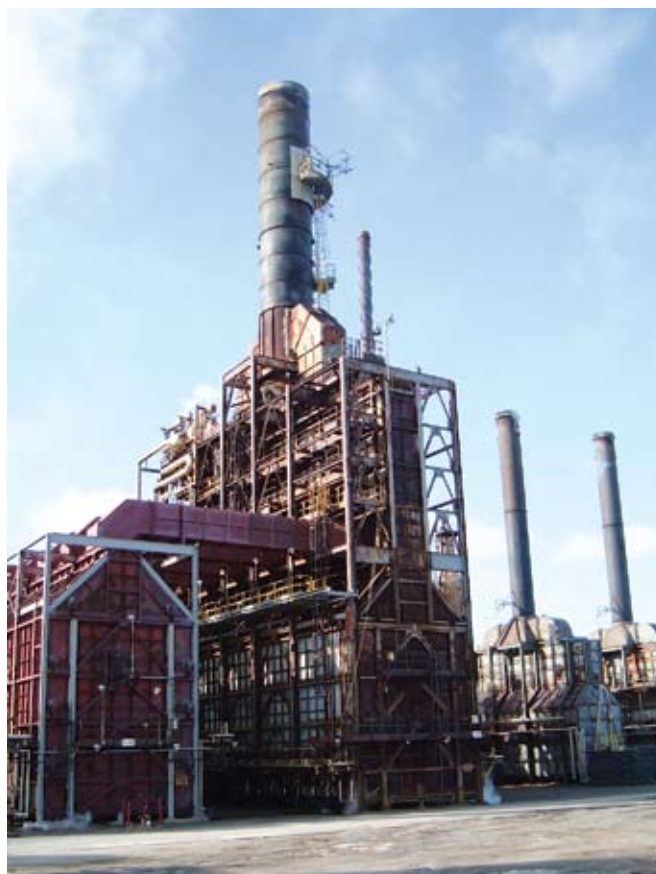
Background. The primary causes for this deterioration were erosion and corrosion. The external erosion was generated due to the close location to the Atlantic Ocean under some of the most extreme weather conditions in any part of the world. Internal corrosion resulted from the fuel-oil composition containing high sulfur and vanadium. This corrosive environment caused failure of the internal tube sheets due to high-temperature corrosion from the vanadium pentoxide and residue sulfur in the flue gases. Although the tube sheets were constructed with 25Cr–20Ni materials in accordance with the design specifications and temperatures at the time of installation, current specifications would require 50Cr–50Ni–Cb construction materials.

FIG. 1 The radiant sections and convection section of the Come by Chance refinery were deteriorating due to severe North Atlantic climate.

The original construction used bolted panels and had no seal welding. In an environment that features heavy rain, snow and fog, moisture was constantly being drawn into the structural seams by negative pressure inside the convection box, combined with capillary action. The contacting and condensing of flue gases created sulfuric acid. This acid became the corrosion source of the inner shell and refractory anchorage.

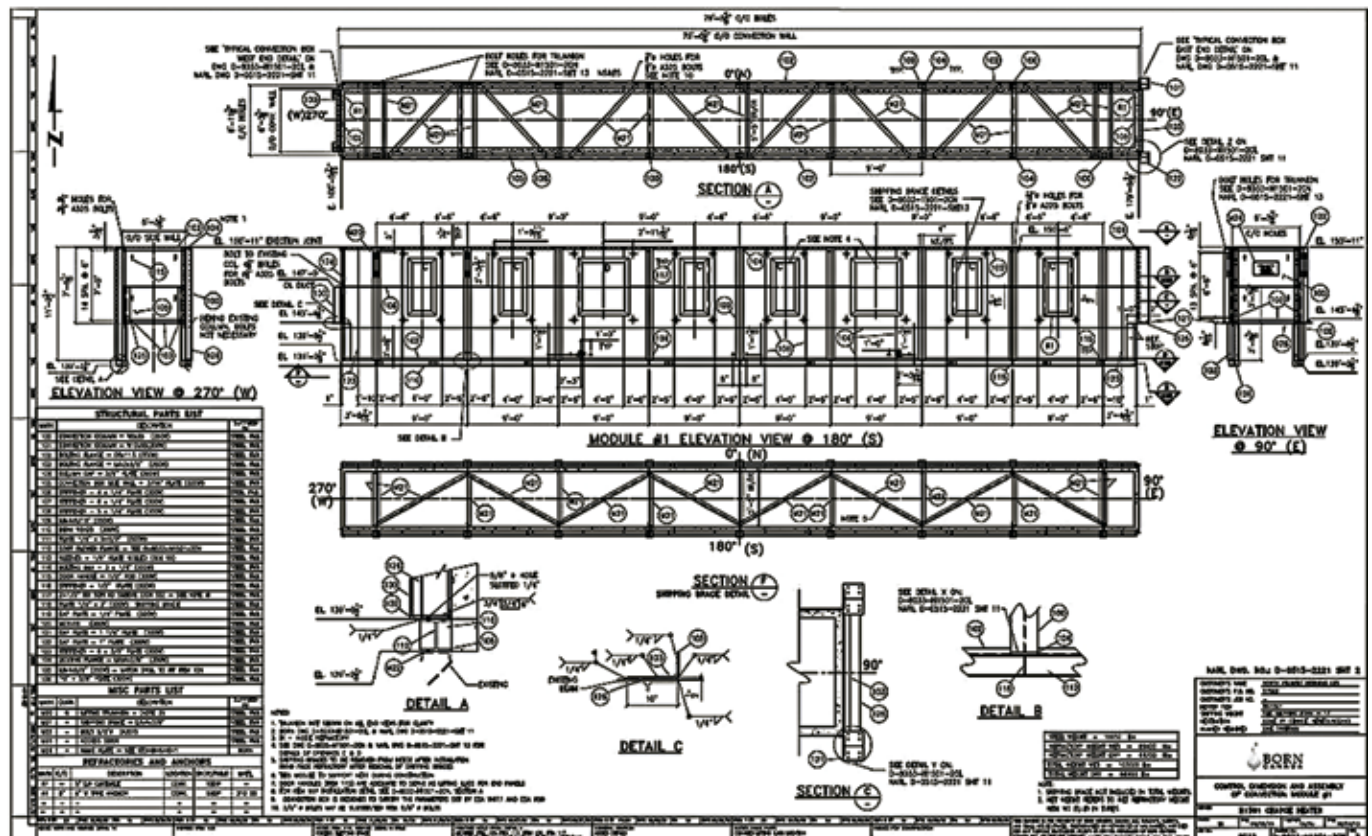
while carefully ensuring that the final weight of the new unit did not exceed the weight of the original convection section (Fig. 2). The new design consisted of 18 rows of steam-generating carbon steel tubes and another three rows of Cr-Mo, P22 tubes that would service as the steam superheater coils. This maintained the original steam superheater configuration while removing six rows of steam-generation tubes.

FIG. 2 Detail drawing of a typical convection section.

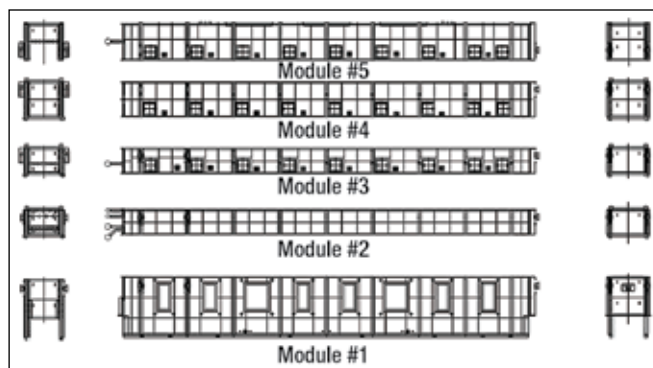
From the start, the design team and the client’s intention was to fabricate this convection box in completed modules—all the steelwork, tube supports, tubes and castable refractory installed (Fig. 3). The goal was to minimize the number of modules and to improve field-erection efficiency while not exceeding the capacity of the available cranes. The size of each module was based on the initial weight and crane estimate.

FIG. 3 Modularized convection box of the reformer heater.

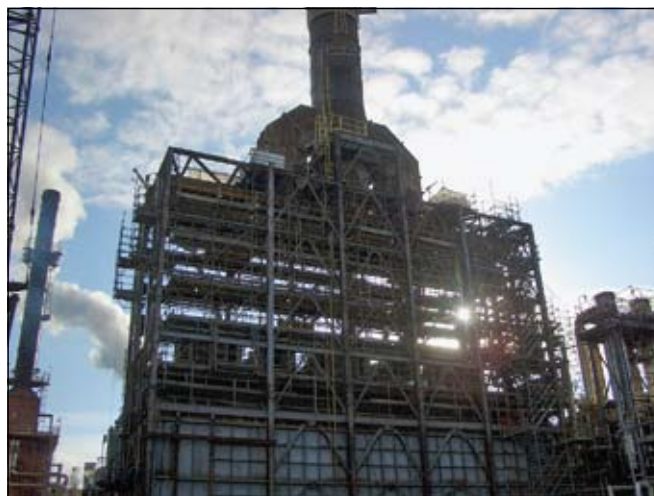
FIG. 4 The convection box after demolition; the skeleton is available for new construction to begin.

of the new modules (Fig. 4). All lift preparations were conducted during the daytime hours, while the lifts were conducted during the night when gentler Newfoundland winds prevail.

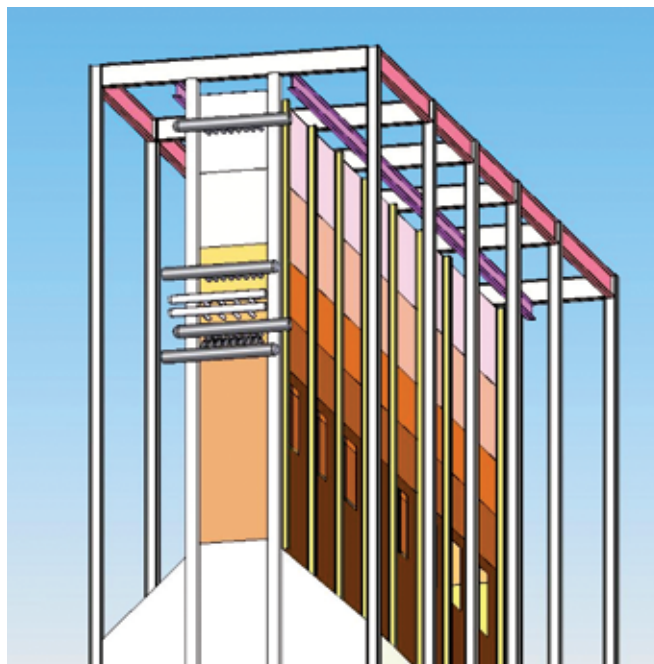
FIG. 5 New convection box in the existing skeleton; the erection beams are shown as purple.

A concept was developed to reuse the beams that were in place at the top of the structure (underside of stack structure) and were used for the construction of the original convection box. Due to their unique position on the existing structure, the five modules created a solution by using “trolleys” that would slide along these erection beams (Fig. 5).

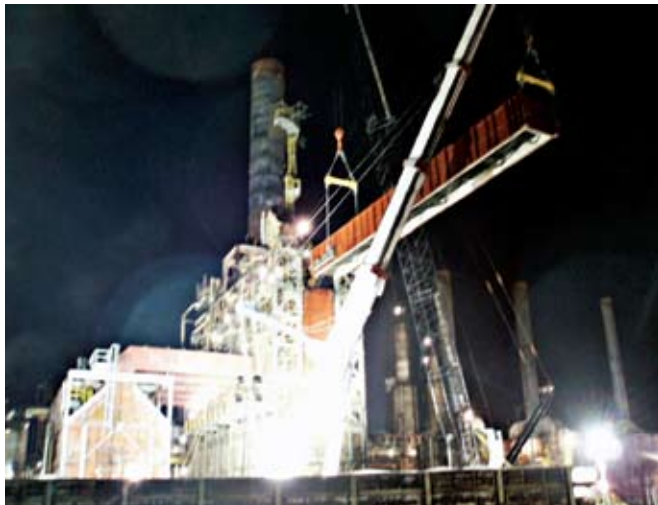
FIG. 7 Lifting of Module 5 during the revamp of the reformer heater.

The erection sequence was to bring each module on the special hydraulic ride trailer and position it under the trolley beam. From that point, each module was to be lifted vertically with two conventional cranes (one at each end). As the module made its way up, the crane closest to the furnace would secure and gradually transfer its load to two trolleys. The trolleys would progressively move toward the opposite end of the heater moving the module along with them. The crane on the further end would extend its boom to accommodate the movement of the modules toward the furnace (Figs. 6 and 7).

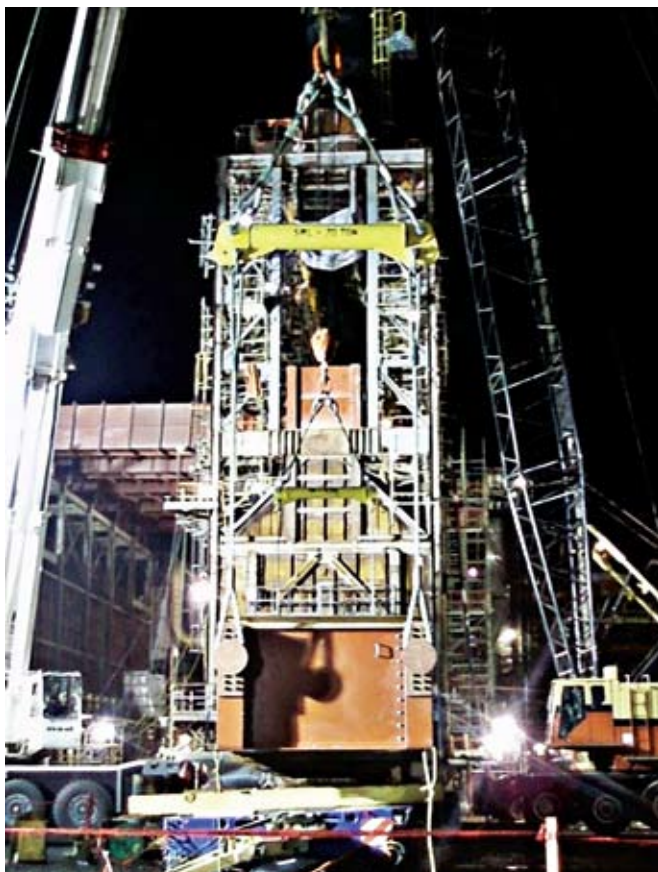
FIG. 6 Module 1 is erected and Module 2 is being lifted. Both cranes use trolleys in the background.
